ADDENDUM 2
Via E-Mail
DATE: February 24, 2021

Contract 21-C-00012 Hillsborough River Dam North Embankment Remediation

Item 4: Attached is a copy of the Hillsborough River Dam Final Engineering Report dated May 24, 2019.

Subject: Hillsborough River Dam TO-3 Phase 2 Task 1 Geophysical Investigation Report

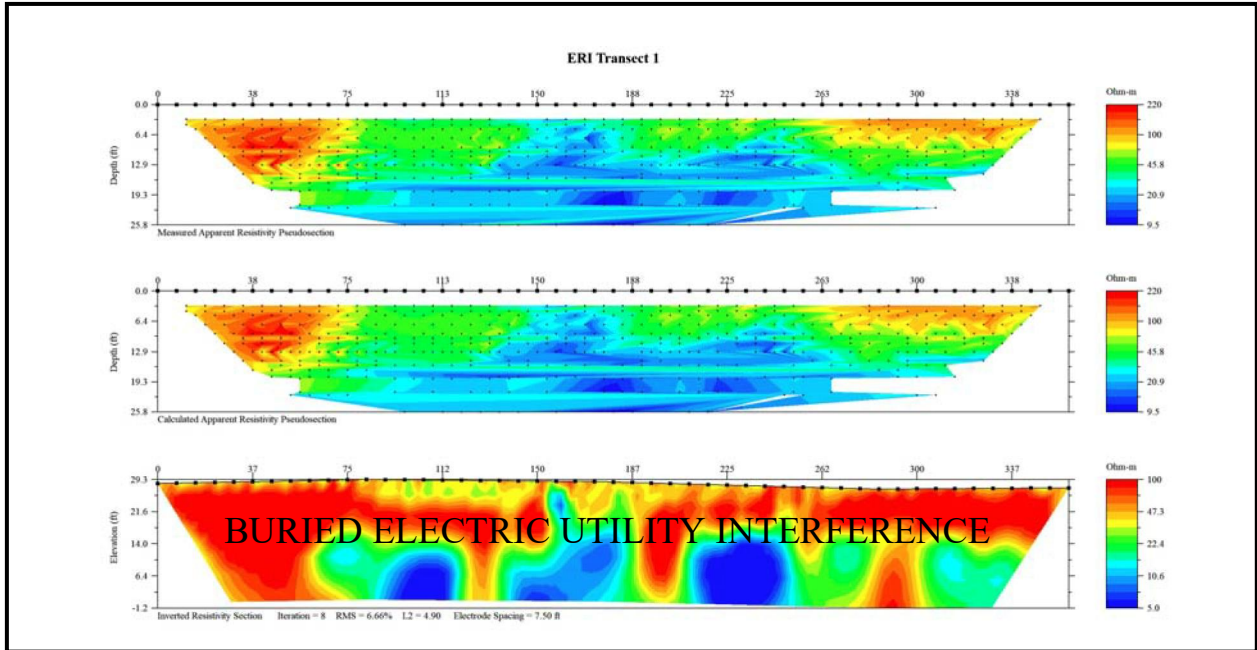
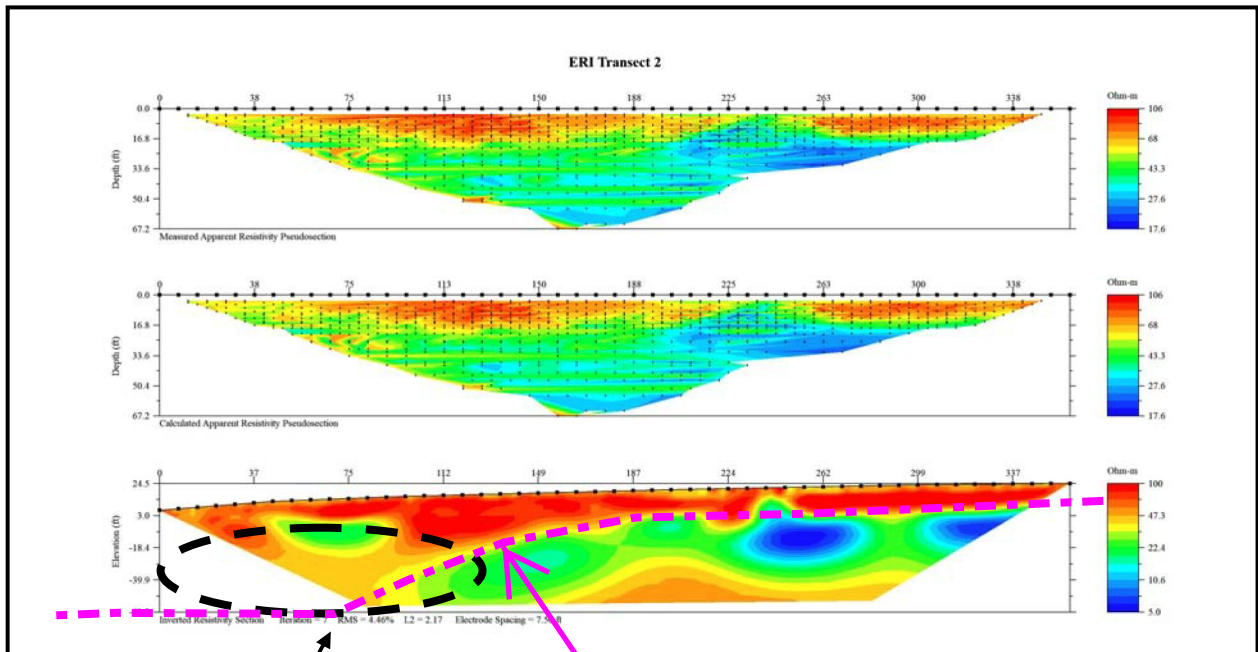
FIGURE 2: ERI IMAGING DETAILS FOR ERI TRANSECTIONS 1 & 2

ERI Anomaly 1

Estimated Top of Limestone

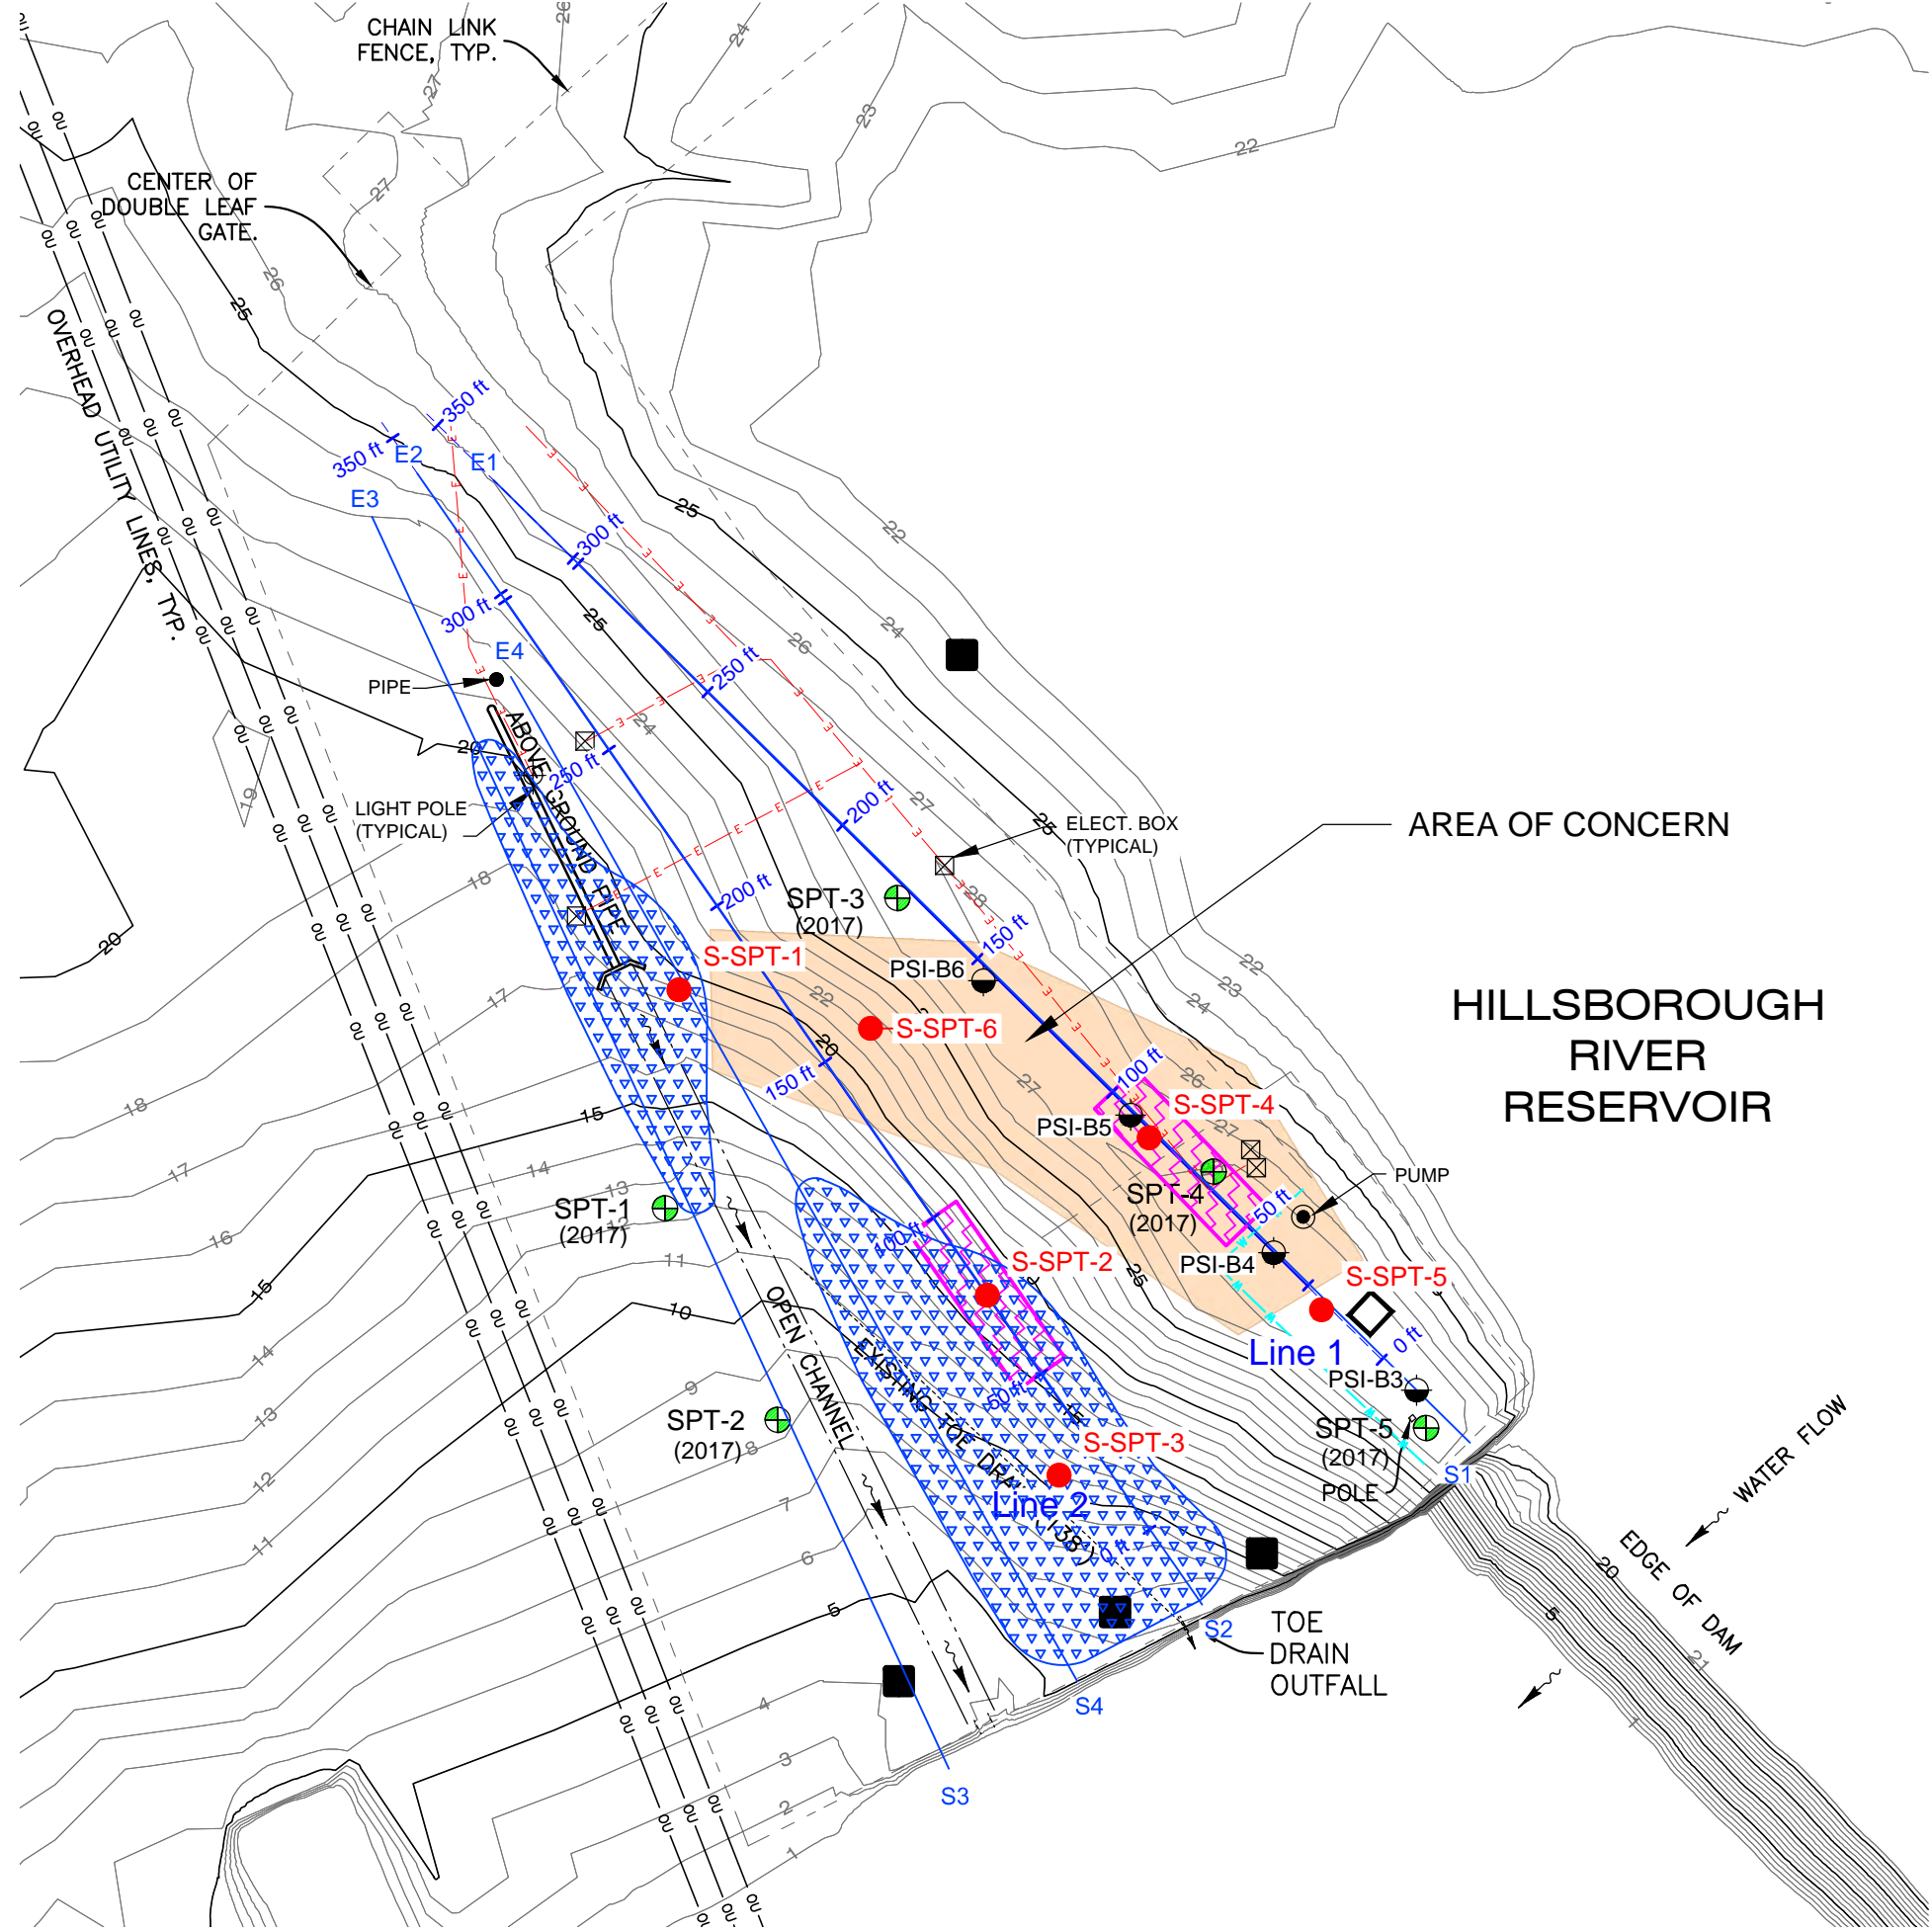
FIGURE 2

- **Figures 2, 3, and 4** show the anomaly areas indicated by the ERI and MASW geophysical investigations. The figures also show the location of loose or soft in-filled soils found in the SPT borings where the limestone is either highly weathered or absent due to solutioning. This part of the in-filled karst area is highlighted as "Area of Concern." This

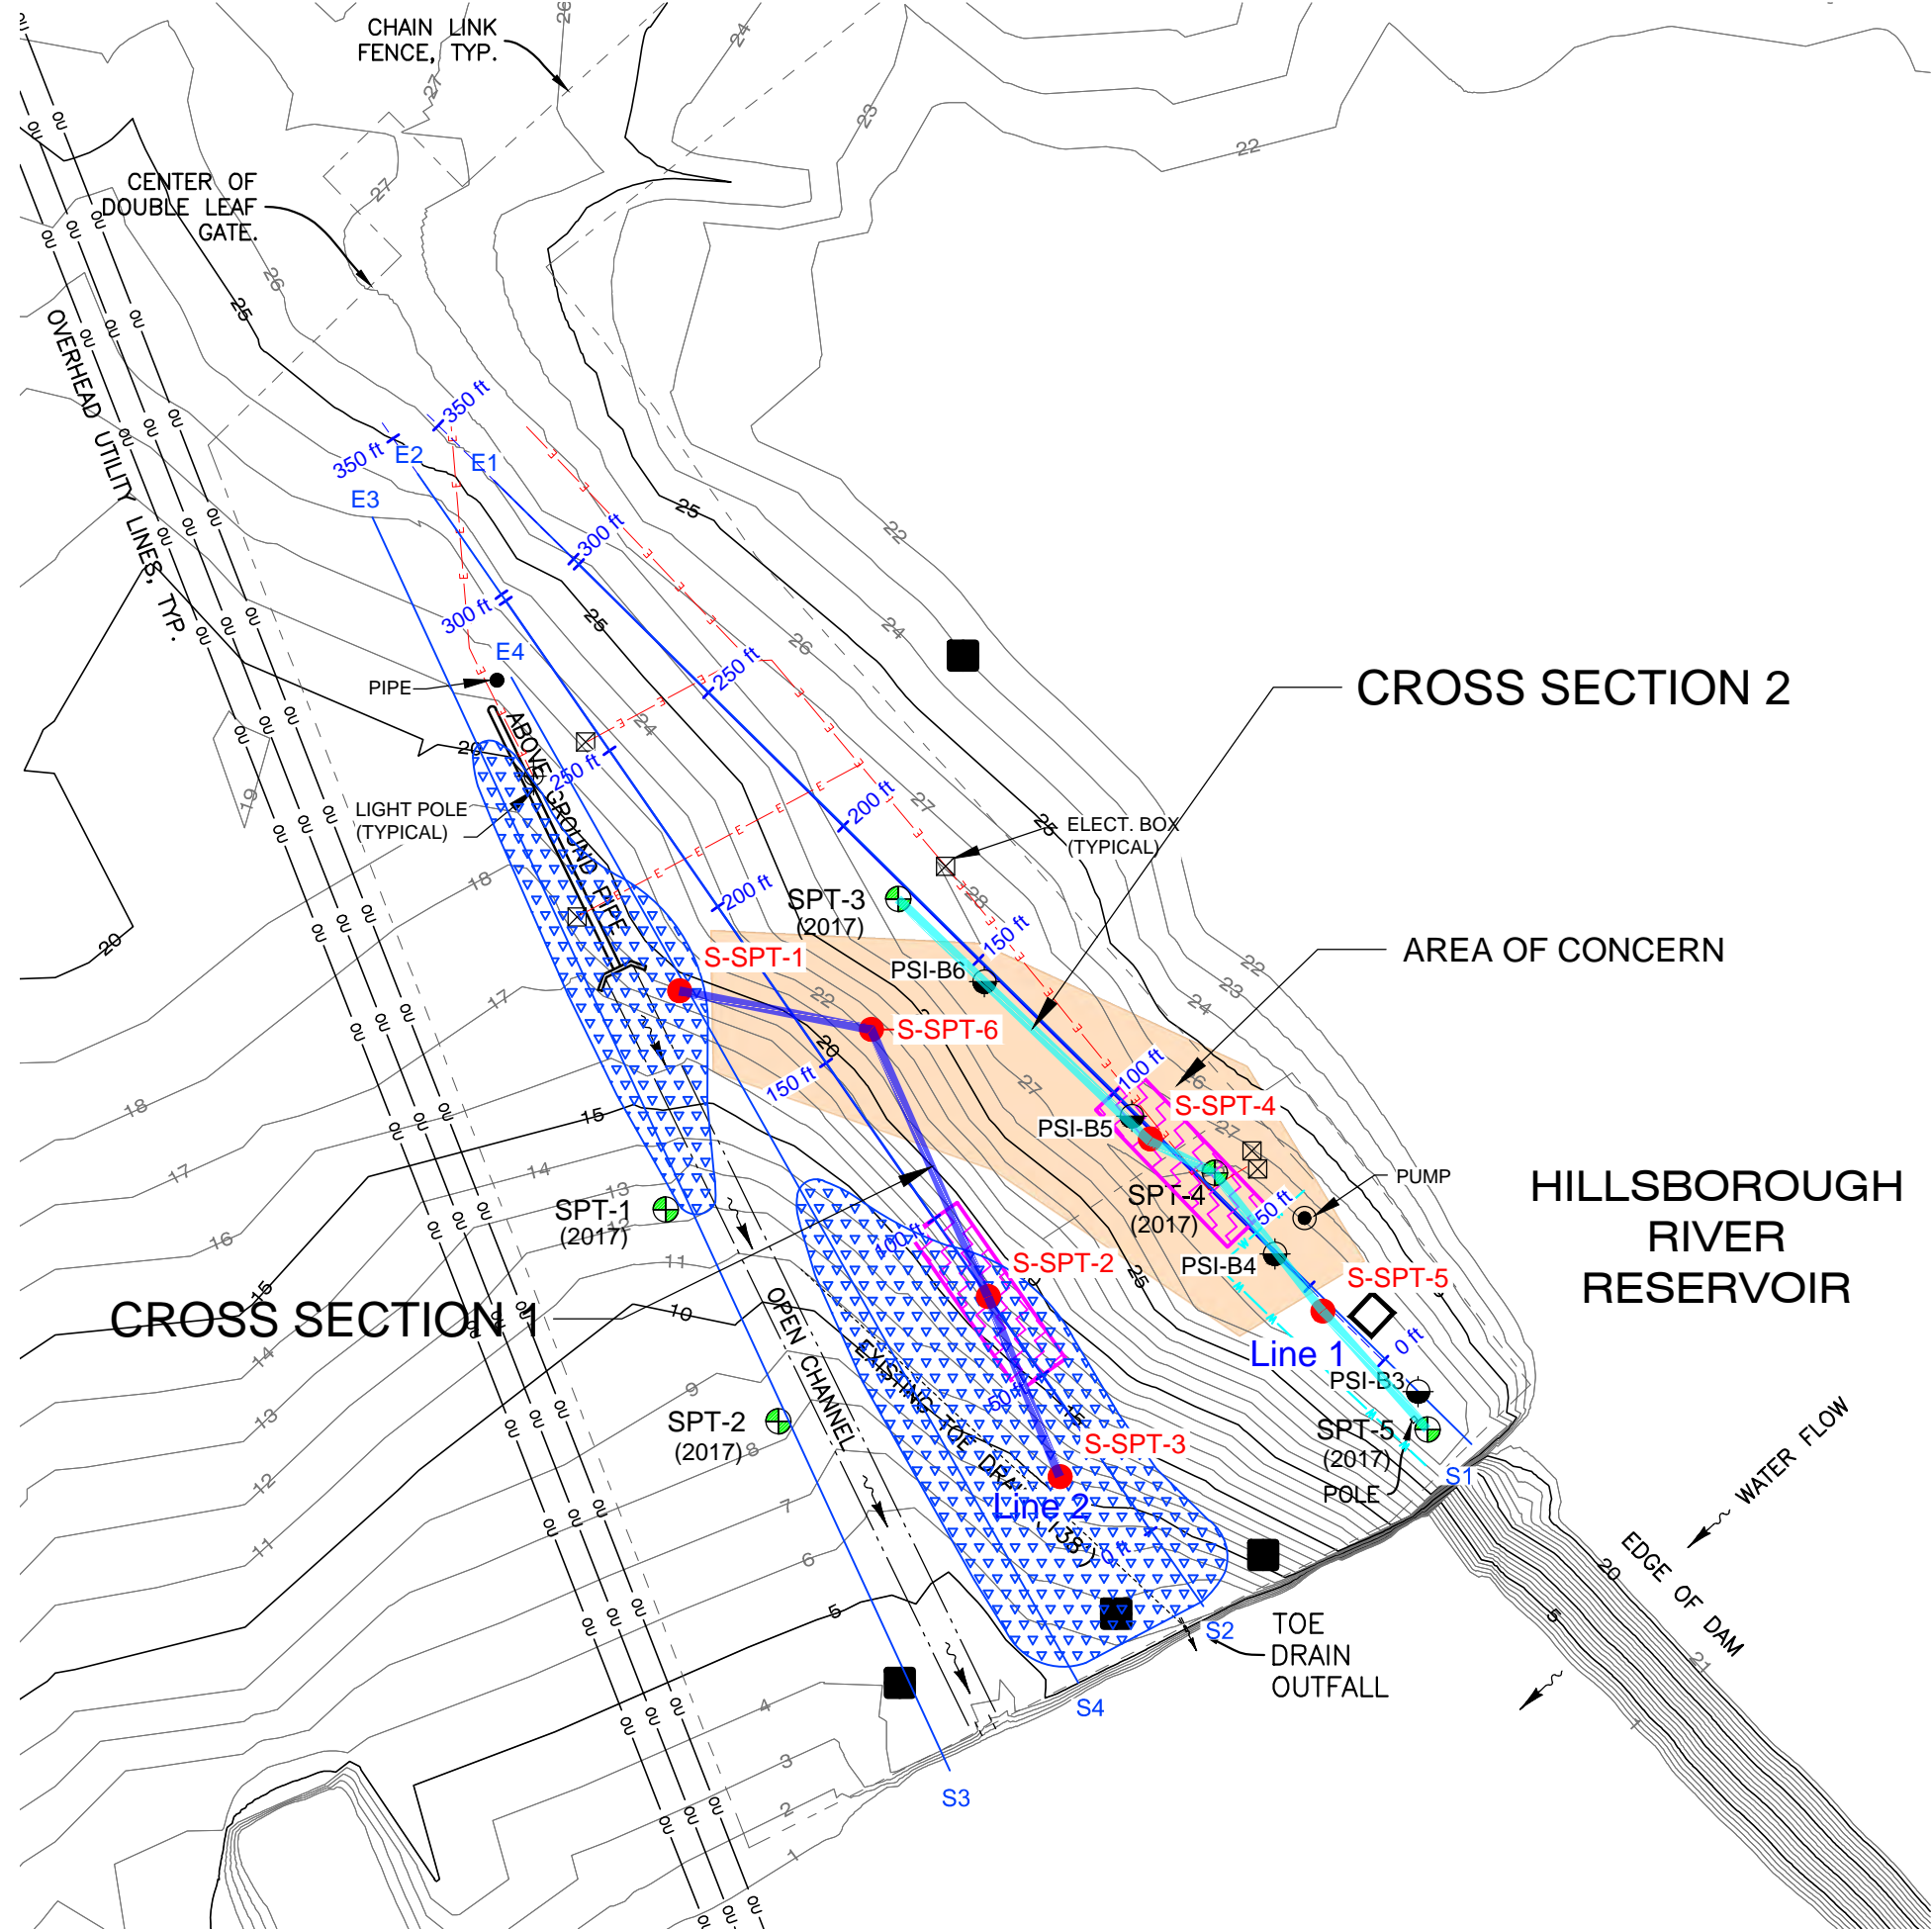
FIGURE 3

- **Figures 3 and 4** also show the locations of six cross sections selected to show subsurface soil and rock conditions at the North Embankment Dam. **Figures 5, 6 and 7** show the cross sections, which include all of the SPT borings. It can be noticed that the top of the limestone rock, where limestone has not been completely solutioned, varies significantly between elevations +8 to -80.0 feet. This illustrates the tremendous variation in the solutioning of the limestone from one section of the dam to another. It is also worth noting that previous borings beneath the concrete dam section have indicated that the top of rock is at approximately elevation 0, with no indication of significant karst formation. However, it should be recognized that there are few borings beneath the concrete section, and they are limited to the northern part of the dam.

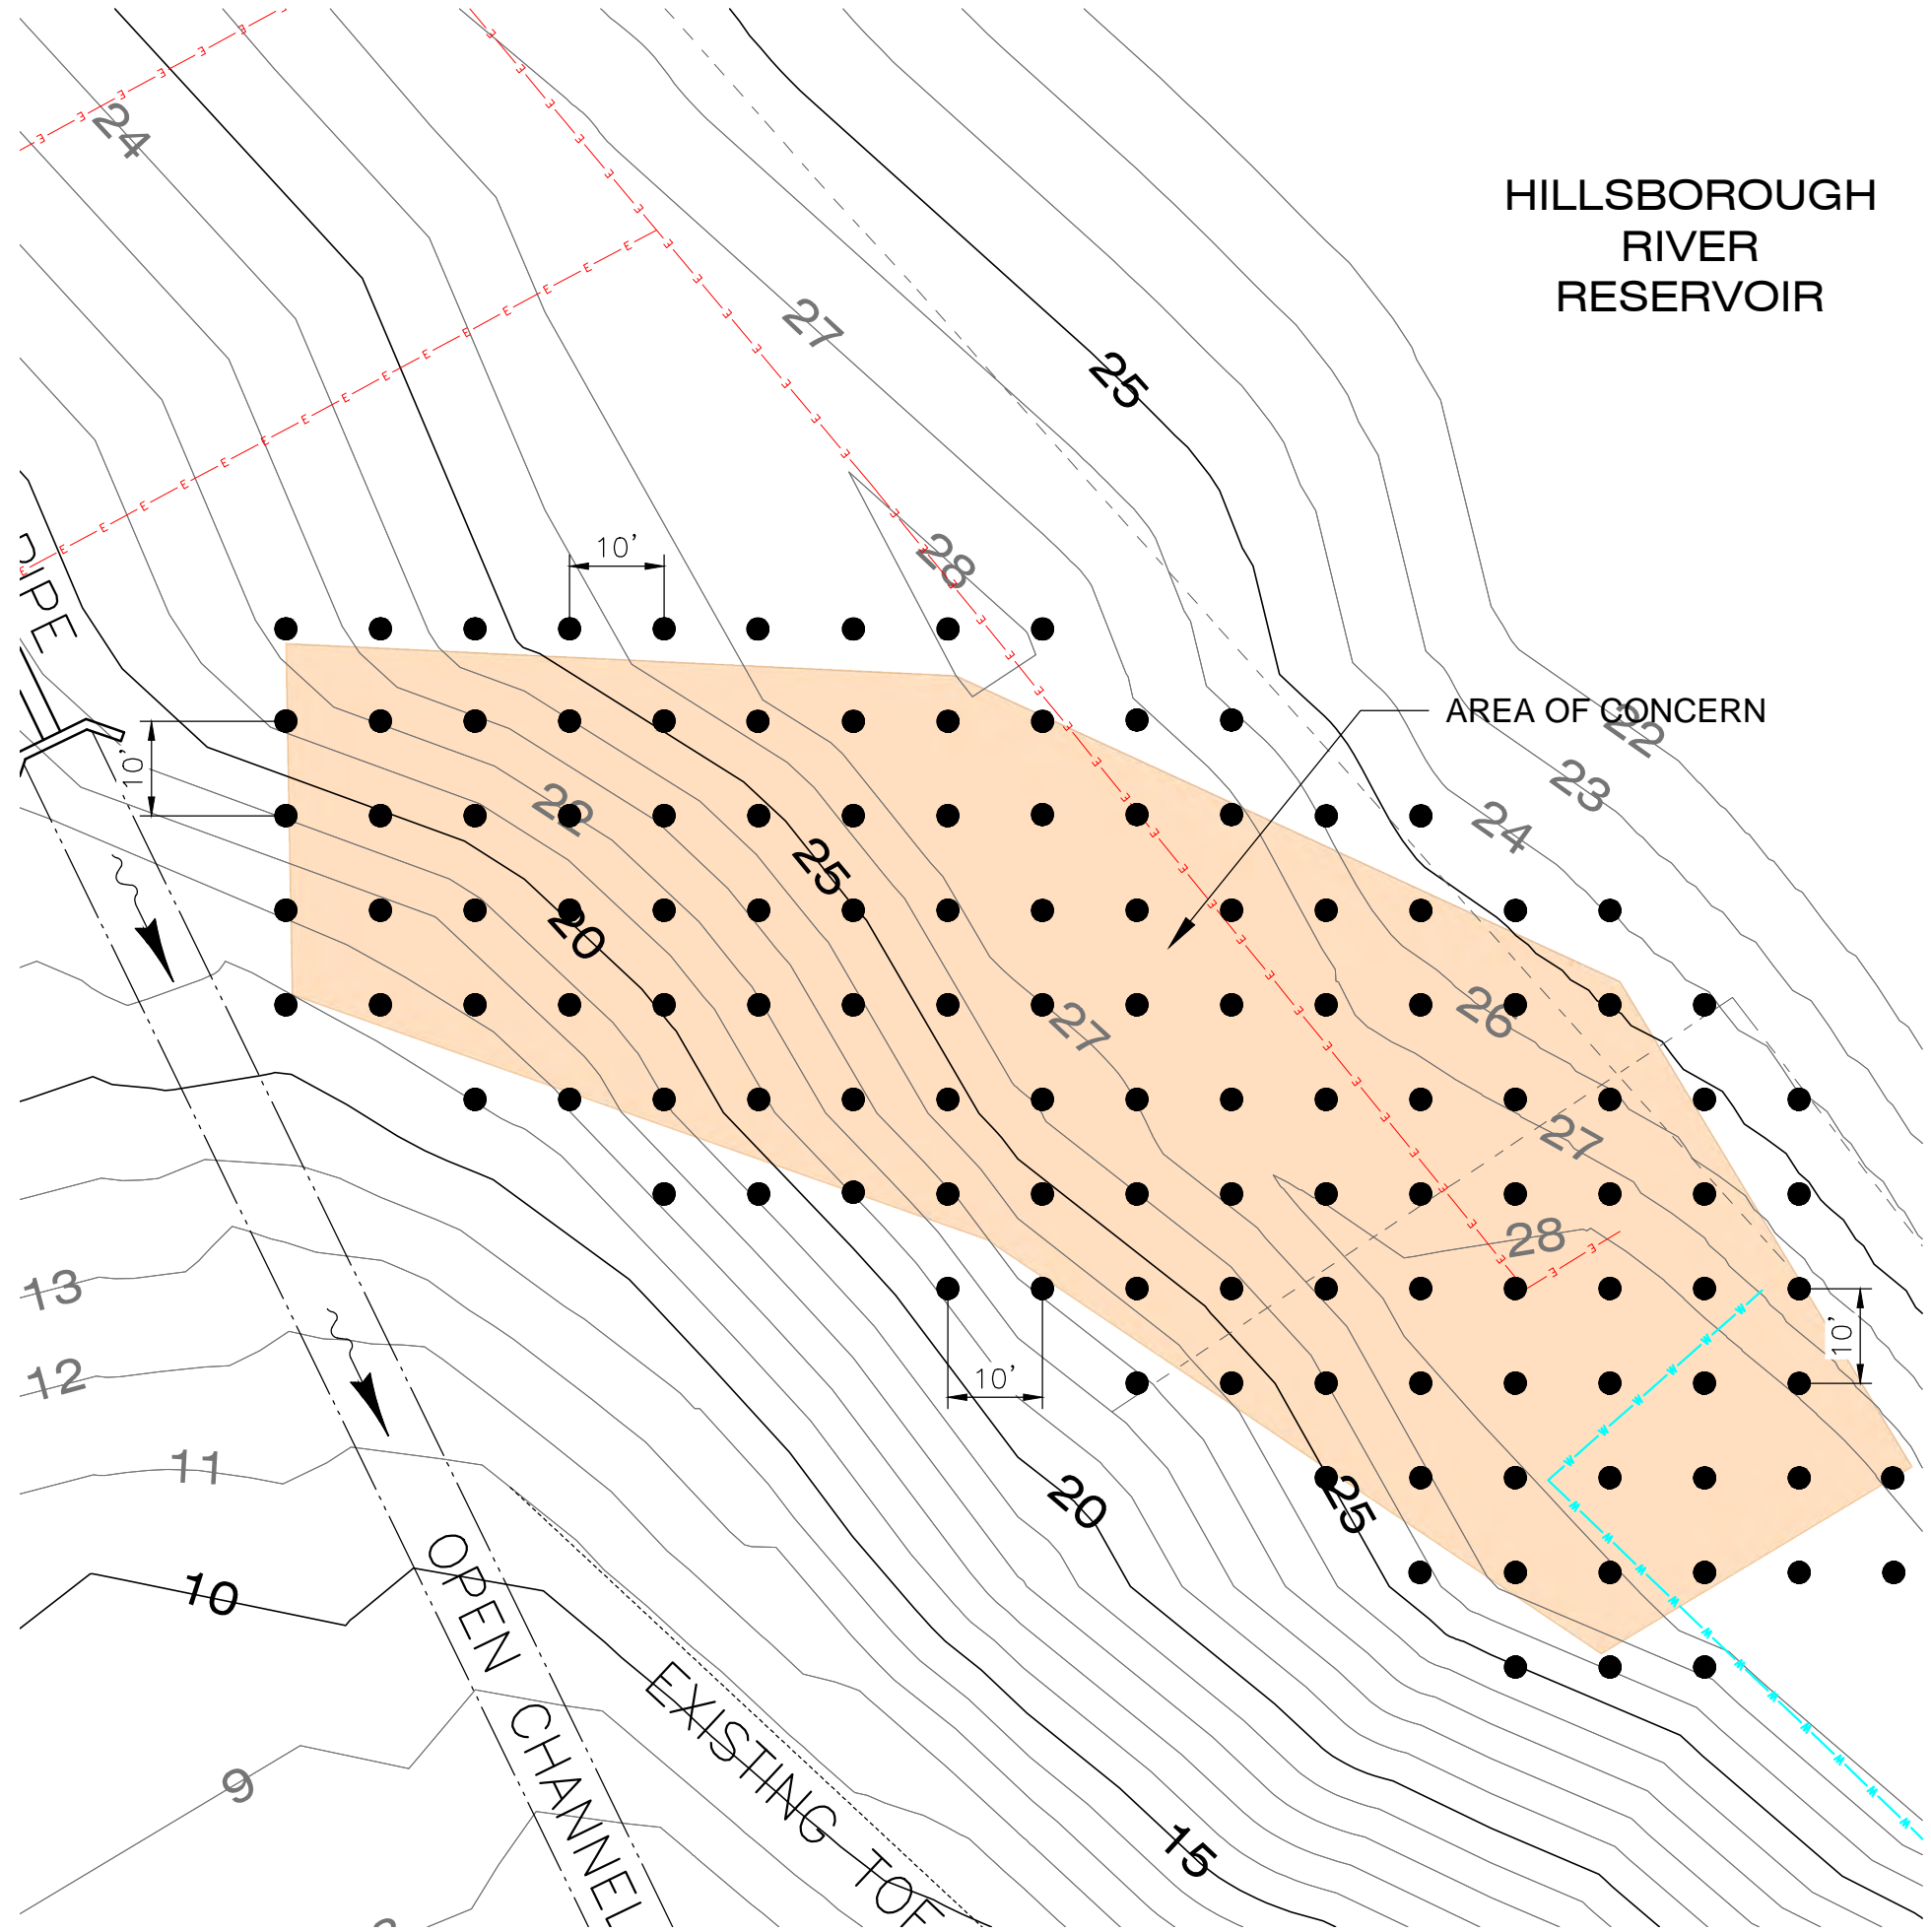
FIGURE 8

After reviewing the investigations performed at the site, it is Wood’s opinion that a portion of the infilled karst feature found at the North Embankment Dam is potentially susceptible to reactivation that could result in significant subsidence and potential breaching of the dam.

The recommended grouting program should consist of a series of primary vertical grout injection points in the area of concern identified by the geotechnical explorations, as shown in **Figure 8**. A LMG grout should be utilized to ensure effective treatment of the loose/raveled zones and to reduce migration of grout beyond the affected areas.

We estimate the grout quantity will be between 1,130 and 2,260 cubic yards. The LMG grout should have a slump of 3 to 5 inches at the hopper with a minimum compressive strength of 400 psi at 28 days. The recommended maximum injection pressure should be 150 psi above line pressure.

The proposed remediation plan consists of one hundred twenty-six (126) primary vertical grout injection points, on a 10 ft by 10 ft pattern, at the locations shown on **Figure 8**. We note that additional, intermediate grout points (secondary and tertiary) may be necessary if high grout volumes are recorded during the grouting program. In that case the grouting program may move outside the proposed primary grouting area until stable conditions are encountered.
