# El Prado Blvd.

MOBILITY OPPORTUNITIES AND  
DEFICIENCIES AUDIT  
2020

DECEMBER 2020

**CITY OF TAMPA**  
**MOBILITY DEPARTMENT**

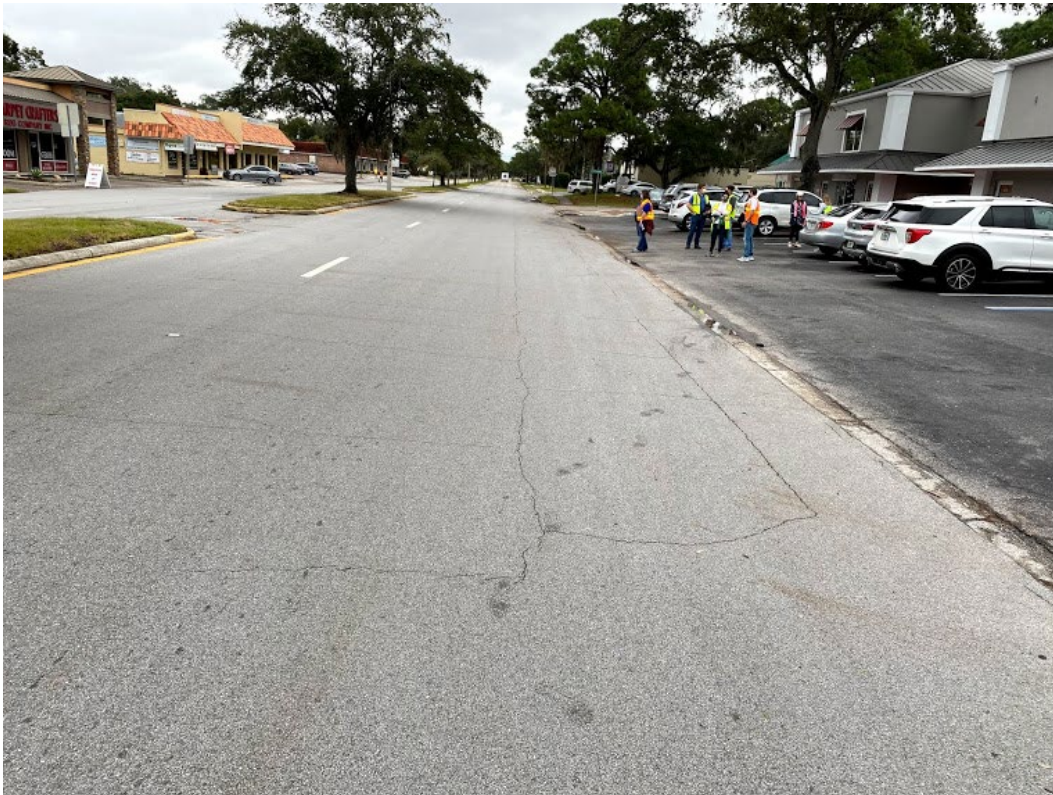
There is a small business district between Hesperides St. and Lois Ave. near the Manhattan Ave. intersection. The pavement widths widen considerably in this section. Several of the businesses have wide curb cuts and parking encroachments within the right-of-way. Considering the wider pavement widths present in this area, on-street parking and/or curbside pick-up/drop-off spaces may be options.

*Figure 5: Business District near Manhattan Ave. with wide pavement widths that may accommodate parking and long curb cuts that may be consolidated.*

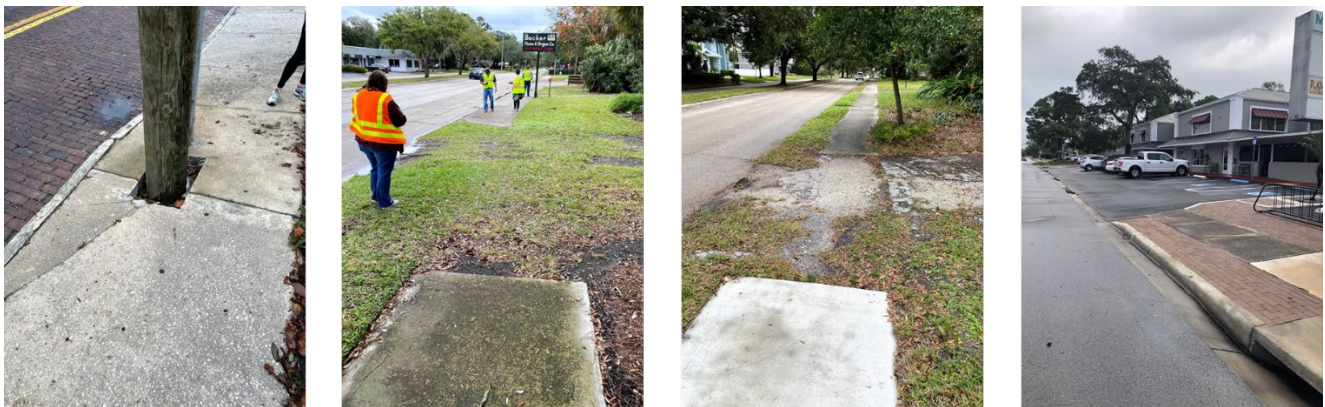
**Figure 7: Sidewalk gaps, drop-offs, and lack of delineation through wide driveways are some of the hazards and accessibility obstacles observed.**

This project will include construction of a 5' minimum concrete sidewalk on the north side of the corridor as part of the federally funded Transportation Alternatives Project. The approximate right-of way width is 100' for the majority of the corridor, narrowing down to approximately 40' from MacDill Ave. to Bayshore Blvd. The north side sidewalk should be designed to be linear, with variations to avoid existing conflicts. There may be several encroachments encountered including utilities, mailboxes, and parking. These encroachments should be evaluated during design. Several driveways are paver driveways that may remain providing that an ADA accessible route can be accommodated. Where parking encroachments are encountered a consistent, clearly delineated concrete walkway should be provided.

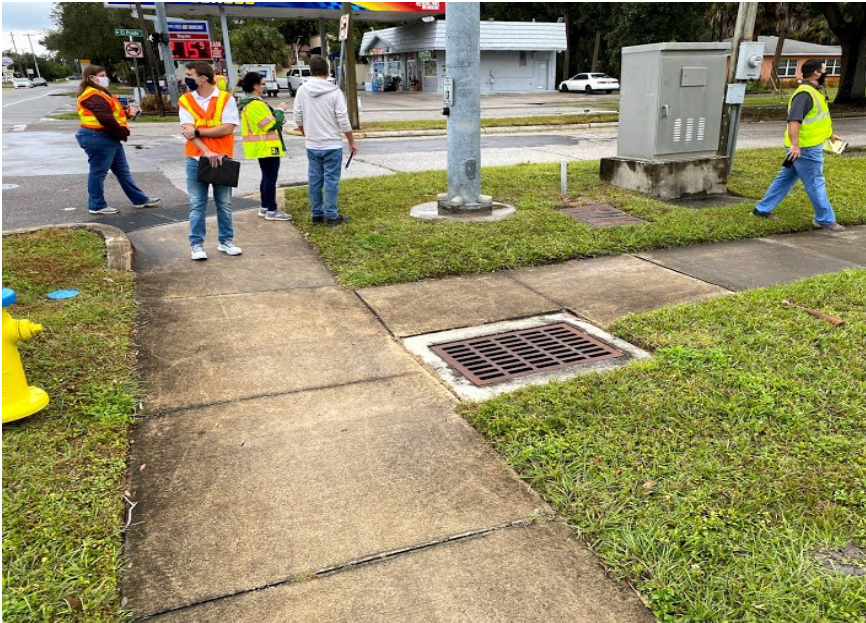
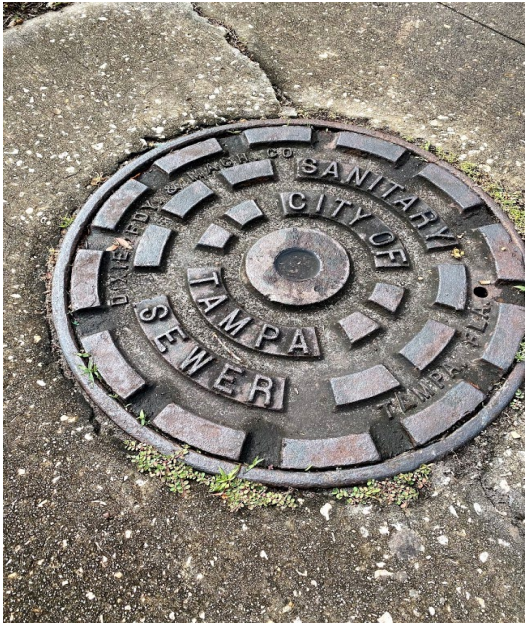
The south side sidewalk should be evaluated for ADA concerns and existing sidewalk condition. All curb ramps shall be upgraded to current ADA standards. There is a portion of the southside sidewalk immediately east of the West Shore Blvd. intersection that acts as a swale to convey stormwater runoff to a grate inlet. Design alternatives and alternate drainage inlet tops should be evaluated during design. Finally, it was noted that there are several sanitary manholes in the south side sidewalk that may not meet ADA standards. Push buttons at the signalized intersections were often inaccessible. These should be considered during design.

*Figure 8: Drainage inlet within sidewalk in area of sidewalk swale (left); sanitary sewer manhole cover within southside sidewalks (right)*

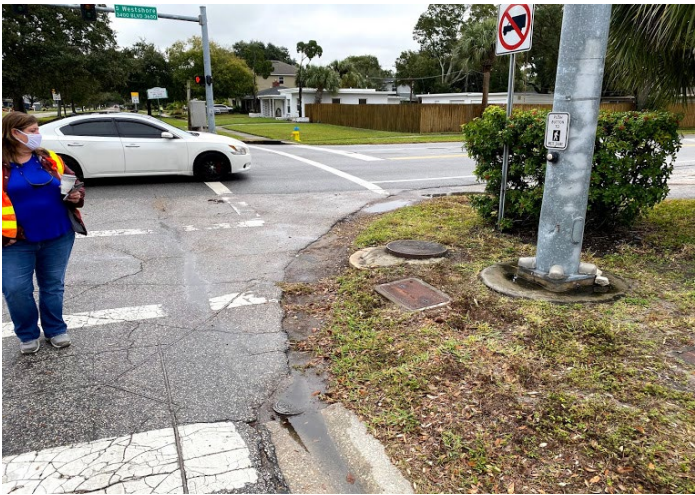
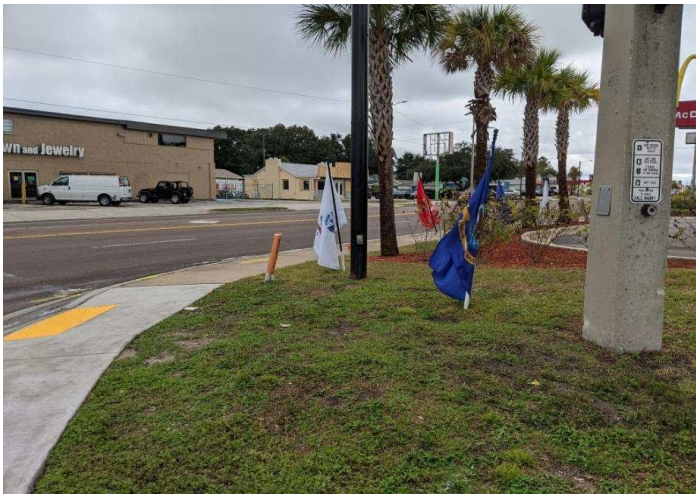
*Figure 9: Inaccessible push buttons at West Shore Blvd. and Dale Mabry Hwy, left and right, respectively*

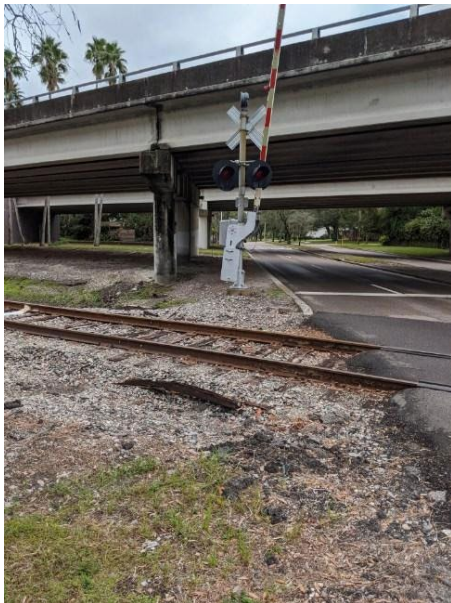
**Figure 10: CSX Rail crossing with no sidewalk on north side**

Currently, the two largest barriers are Dale Mabry Blvd. and the CSX Railroad crossing. The Dale Mabry Hwy. intersection should be considered for improvements to the pedestrian facilities. Sidewalks and bike facilities across the CSX rail line should be included within the project.

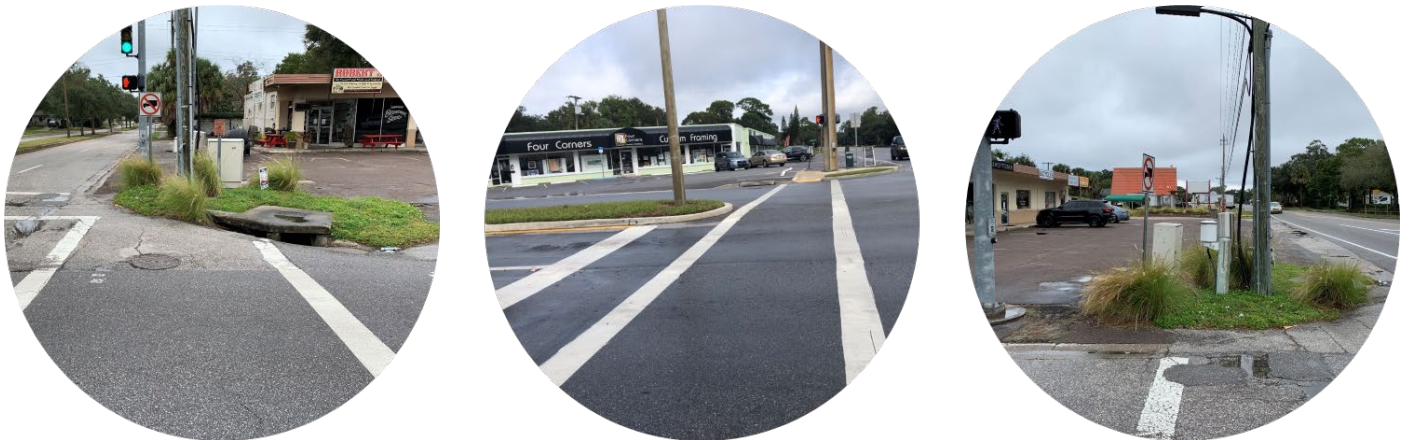
*Figure 12: Long crossing distances for pedestrians and lack of ramps and landings make intersections dangerous and inaccessible.*

All signalized intersections should be analyzed to determine needed operational and safety improvements, especially considering the proposed lane diet. Unwarranted space may be used to better serve multimodal users. Crossing distances should be reduced and opportunities for pedestrian refuge islands should be evaluated. Signal timings, bike specific striping (bike boxes), cyclist detection, right turn restrictions, and leading pedestrian intervals (LPI) should be considered.

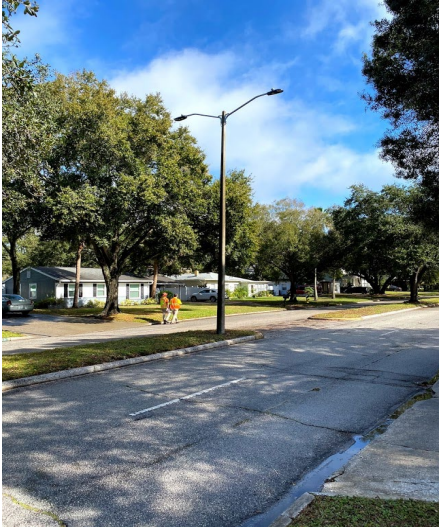
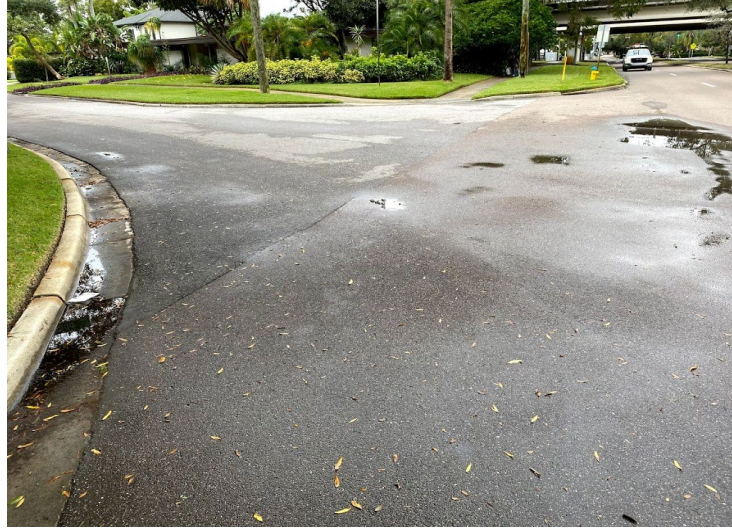
The intersection of Drexel Ave. is skewed with large curb radii, creating long crossing distances. Reconstruction of a portion of the curb returns and the median islands should be evaluated, along with any proposed pedestrian crossings. Along the corridor, there are several midblock median openings that may no longer function after the lane diet. Considerations should be given to either closing or properly signing for restricted movements (no U-turns) all median openings. However, the designer should work to understand how the public may use these openings.

**Figure 13: Mid-block median openings may not allow U-turns under proposed conditions (left); Drexel Ave. is a skewed intersection with a wide throat (right)**

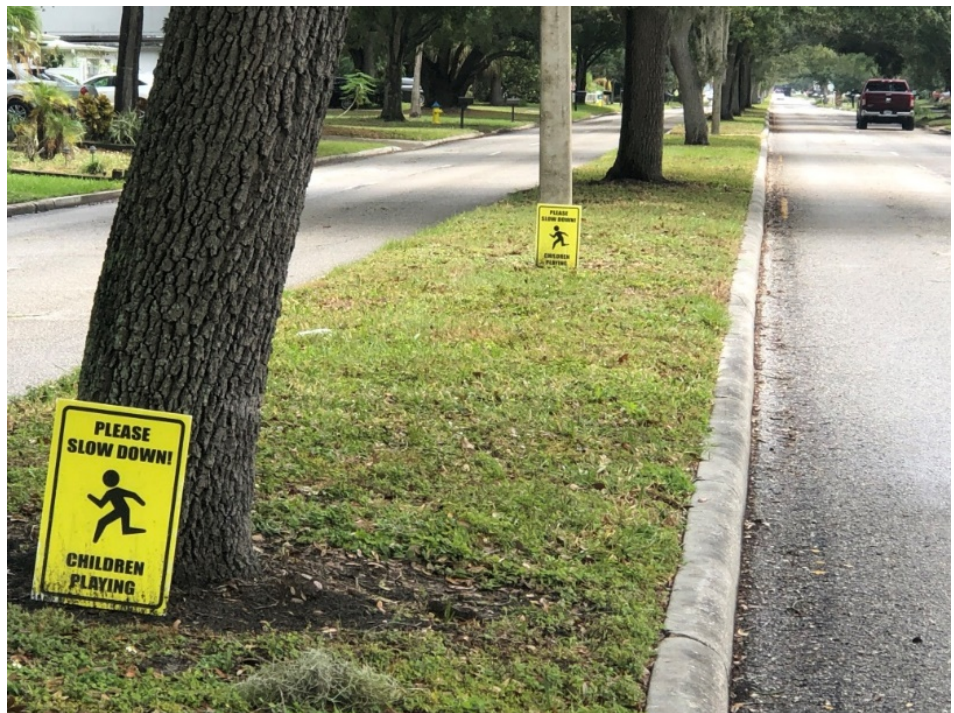
**Figure 14: El Prado residents have already attempted to slow traffic on their own by placing these placards in the median**

Traffic calming along the corridor should be considered. In addition to narrow lanes and enhanced signage and striping, horizontal and vertical deflection should be evaluated as part of the project. The City has incorporated horizontal and vertical deflection as a means to calm traffic on other recent projects. The Hampton Terrace and Ridgewood Park Neighborhood Traffic Calming Projects employed raised medians,

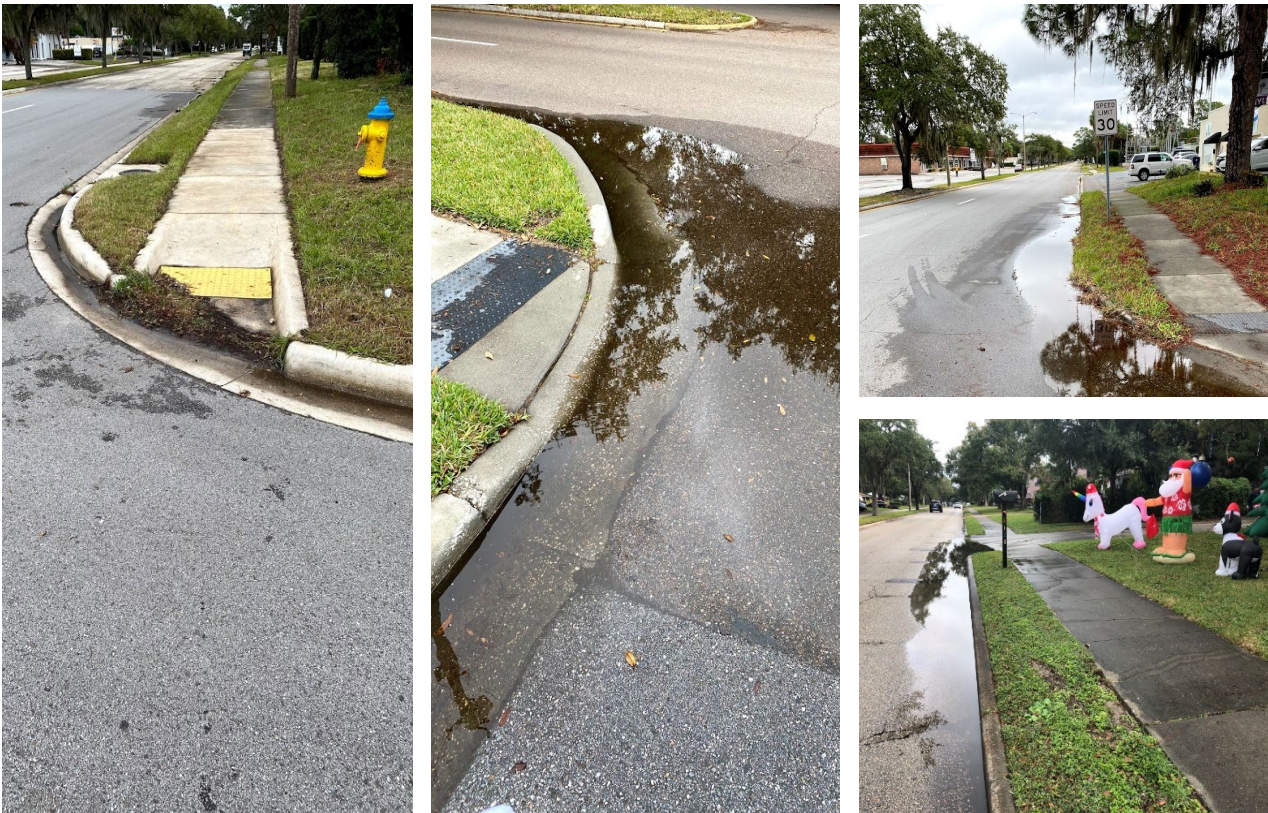
There were several areas of ponding encountered during the on-site audit. Removing ponding through low maintenance methods should be included within the design. Special notice should be placed on ponding within curb ramps and proposed bicycle facilities.

*Figure 15: Ponding and sediment in walkways and bikeways create obstacles that reduce the viability of alternate modes*

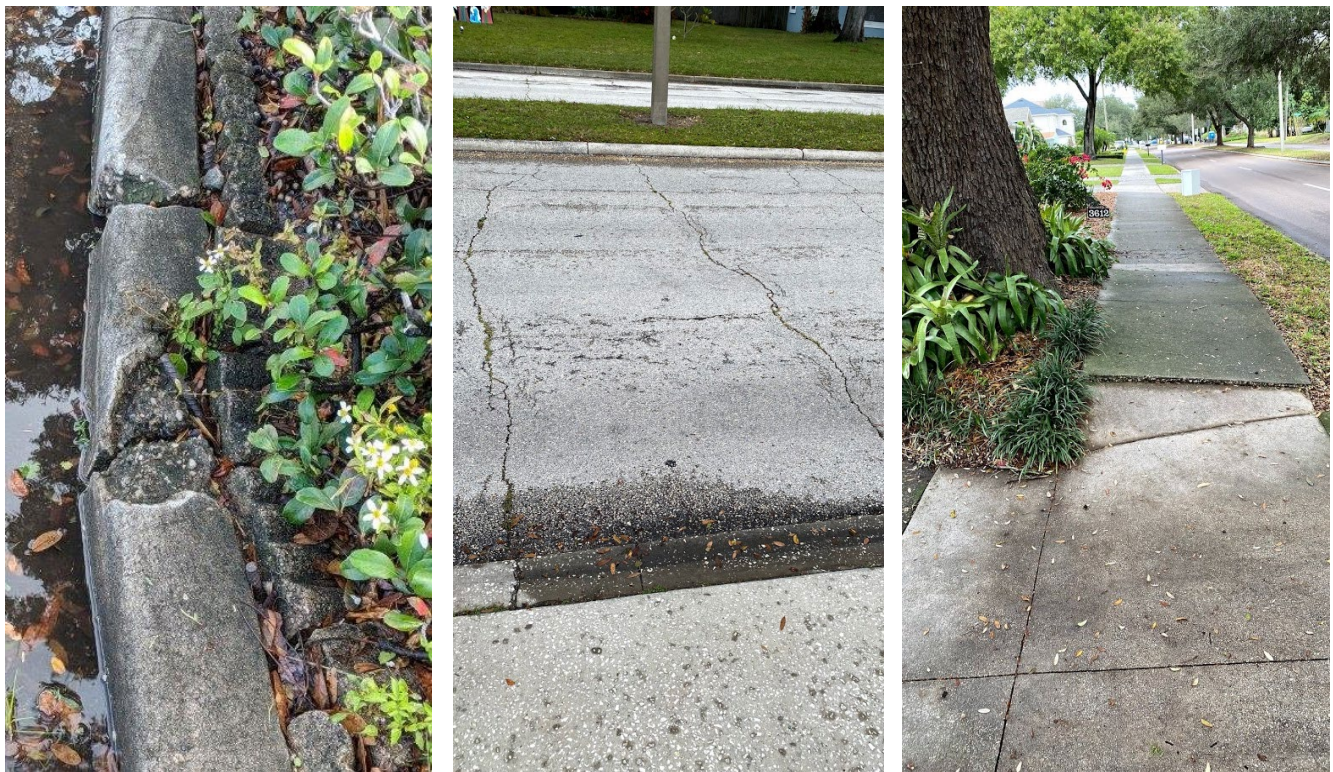
The asphaltic concrete pavement shows signs of several failures. Instances of block cracking were observed during the on-site audit. Recommendations for pavement rehabilitation should be developed during design. Areas of damaged sidewalks were noted on both sides of the road and should be considered for replacement. Several sections of damaged curb were also encountered.

Currently, El Prado Blvd. has a series of relatively young live oak trees that have been planted within a narrow median. Evidence of damage to the existing adjacent pavement was observed. Considering that the roadway is a normal crown section, the damage and uplifting has not caused any drainage issues. However, as the City is proposing a lane diet where vehicular traffic will be forced to utilize the inside lanes, drivability should be considered when evaluating the corridor. Canopy should be evaluated for appropriate clearance. Possible inclusion of a median side shoulder may be considered to reduce future driving surface concerns due to tree roots. Finally, the City's Natural Resources Group should be engaged early in project design development to determine existing tree conditions and evaluate existing trees for pruning or removal.

**Figure 16: The City will look to rehabilitate the corridor assets; broken curb, pavement failures, and upheaved sidewalks should be evaluated for correction.**
