RFQ: 19-C-00042
OLD CITY HALL INTERIOR RENOVATIONS
DESIGN-BUILD SERVICES

DESIGN CRITERIA PACKAGE

CITY OF TAMPA

March 19, 2019

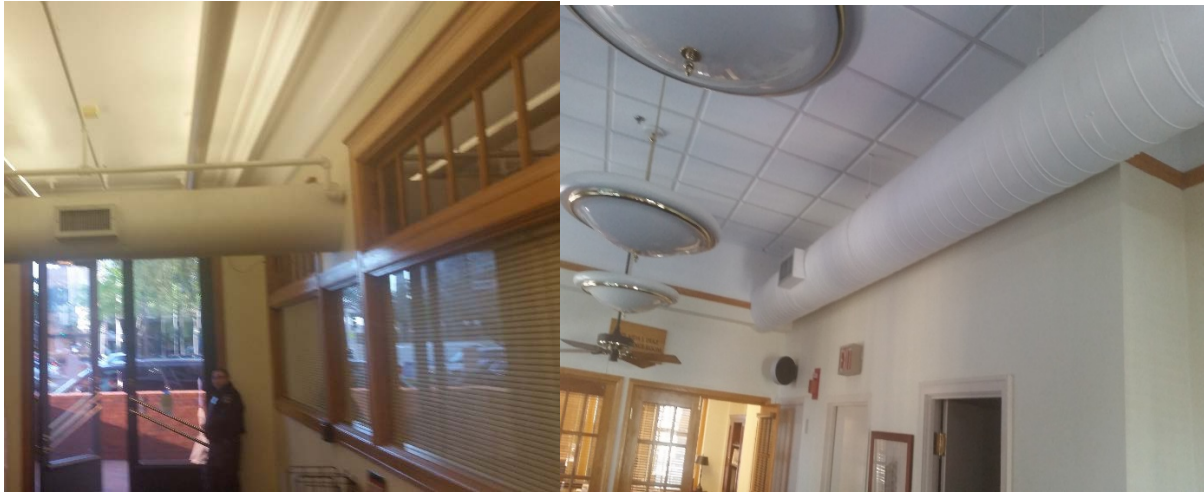
Visible inspection of the exterior of the exposed ductwork was performed at various locations and was determined to be in fair condition. Possible duct cleaning services to inspect and clean the interior of the ductwork should be considered. The routing of the existing supply ductwork would make replacement labor intensive and disruptive to building occupants.

Examples of exposed duct throughout the building.

New supply, return, & outside air duct will be installed within the confines of the mechanical floor and connected to the existing duct risers and distribution system. Modification or replacement of the Outside Air Fans on the 4th floor roof will be required to meet the outside air flow rates required by the current code. The existing ductwork needs to be inspected, cleaned and encapsulated (if needed).

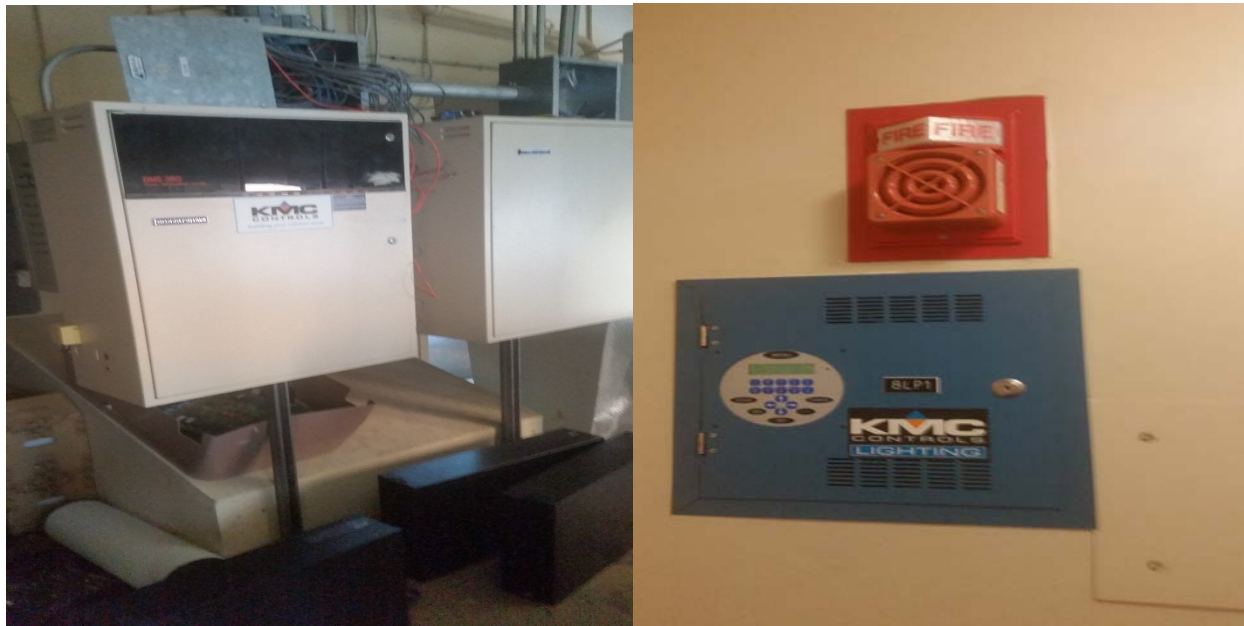
The Direct Digital controls system is currently a KMC system. The current ventilation renovation project incorporates additions to the existing system related to Outside Air intake control and Exhaust systems.

Examples of KMC Controls throughout building

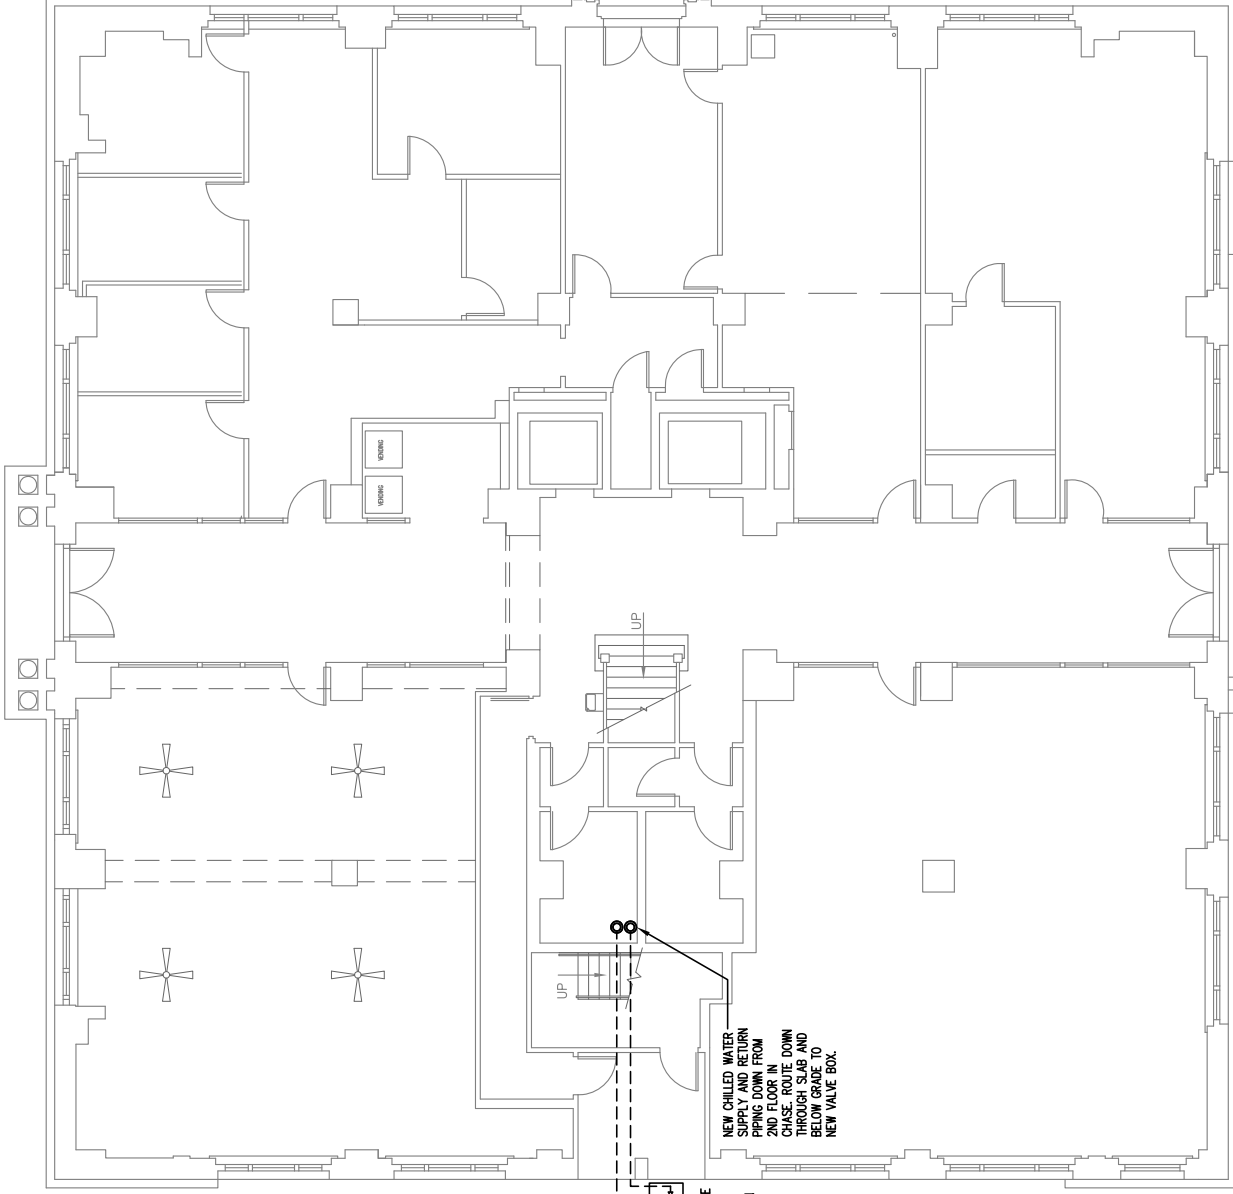
OCH 1ST FLOOR - AUXILIARY PIPING

NEW LOCKABLE VALVE BOX WITH AUXILIARY CHILLED WATER SUPPLY AND RETURN CONNECTIONS WITH ISOLATION VALVES.

NEW CHILLED WATER SUPPLY AND RETURN PIPING DOWN FROM 2ND FLOOR IN CHASE. ROUTE DOWN THROUGH SLAB AND BELOW GRADE TO NEW VALVE BOX.

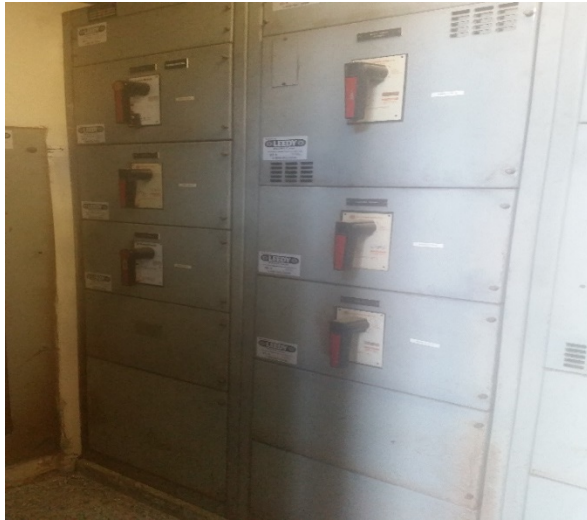
Electrical switchboard – 1st floor TMOB

The main electrical switchboard located in the 1st floor electrical room at TMOB need to be replaced in order to upgrade feeders that service Old City Hall. Also, the electrical switchboard and feeders in the TMOB penthouse that services the HVAC equipment also needs to be replaced. In addition, the main electrical panels located on the 1st floor electrical room is to be replaced in order to accommodate the HVAC equipment in Old City Hall. Finally, the existing fire alarm system in Old City Hall needs to be replaced.

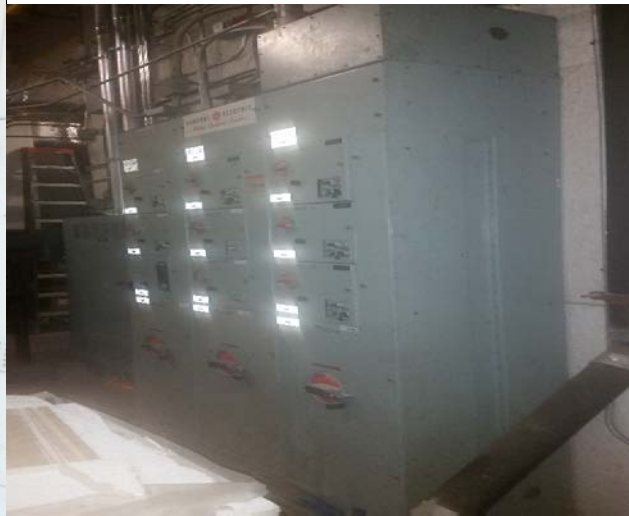
Electrical switchboard – Penthouse @ TMOB

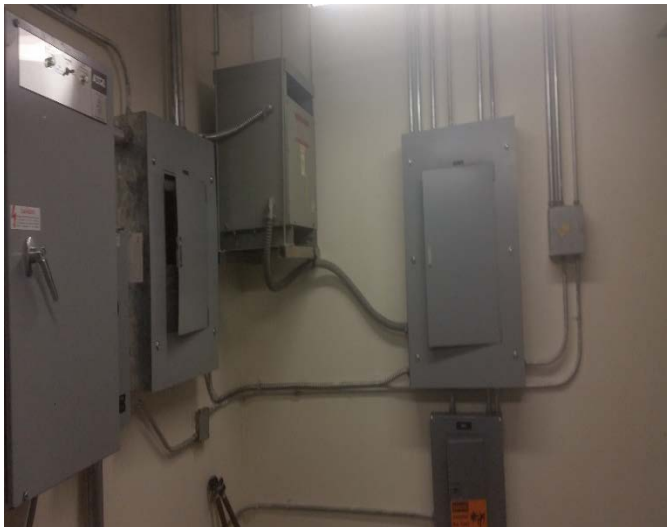
Electrical panels on 1st floor of OCH

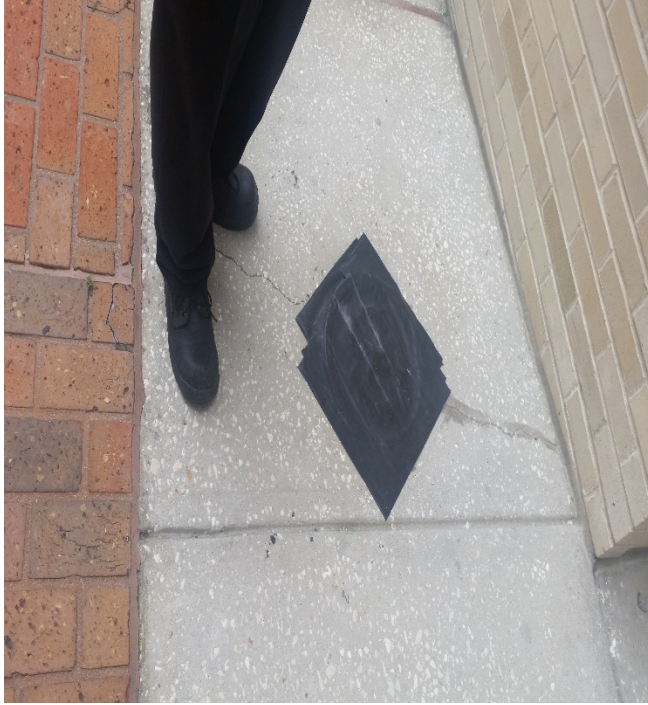
Most of the existing water and wastewater piping throughout the building is cast iron and need to be replaced. In addition, the fire sprinkler riser piping concealed in the walls of the stairwells need to be replaced.

Existing exterior cleanout w/temporary covering

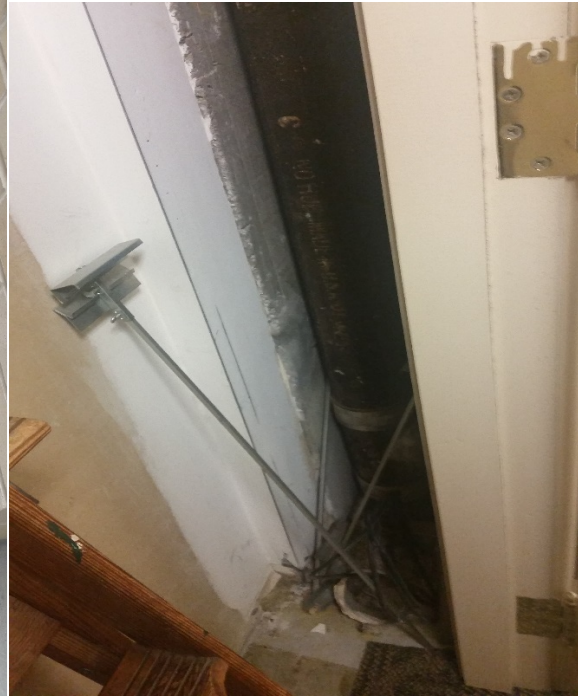
Existing plumbing stack in closet.

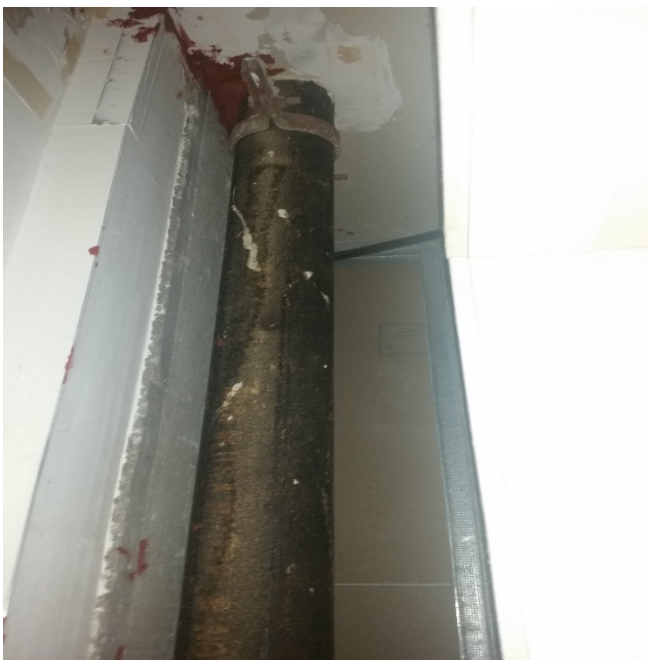
Existing plumbing stack in closet

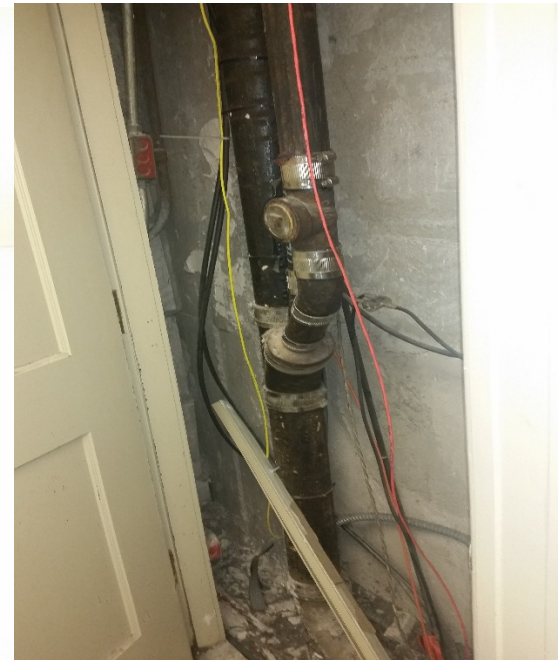
Existing branch stack in closet

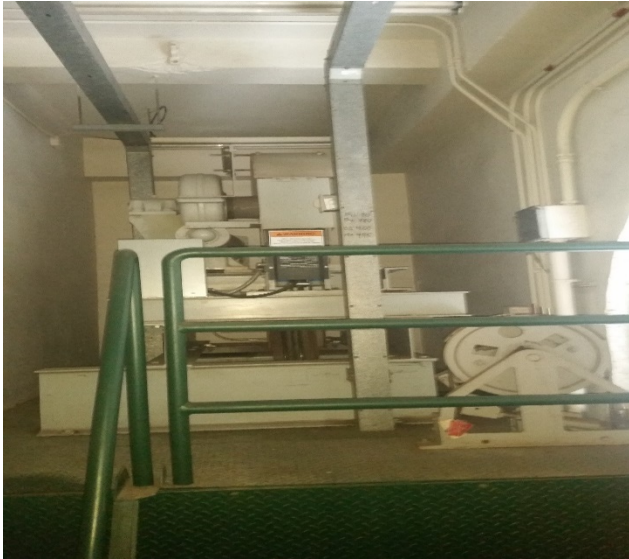
There is an existing elevator equipment room located on east side of the 9th Floor of the clock tower. The elevator equipment is stalled on a elevated mezzanine in the north half of the room. The clock tower has a large semi-circular louver facing each side of the building that provides ventilation for the air handlers installed on that floor. The elevator equipment room does not need to be ventilated and needs to be air conditioned similar to the elevator equipment room on the 4th floor. The vent needs to be covered and sealed along with the replacing of an existing bifold door with weather-stripping in order to provide air conditioning to that equipment room. Surfaces need to be cleaned and repainted.

Elevator equipment at 9th Floor mezzanine.

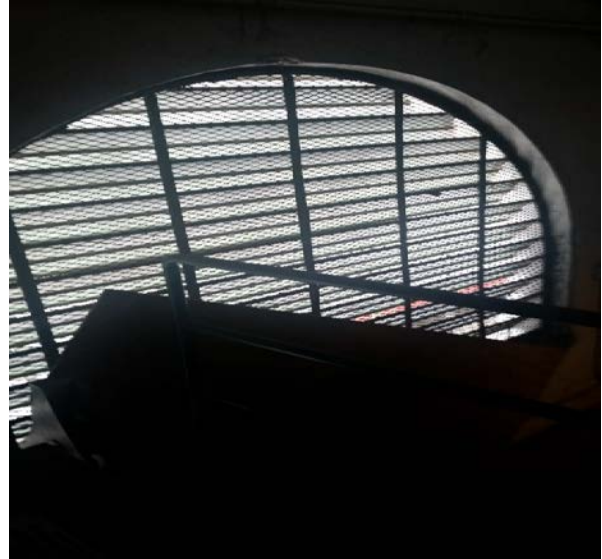
Existing Elevator equipment room grille.

The remaining plaster surfaces around the remaining grilles on the 9th floor need to be repaired and repainted.

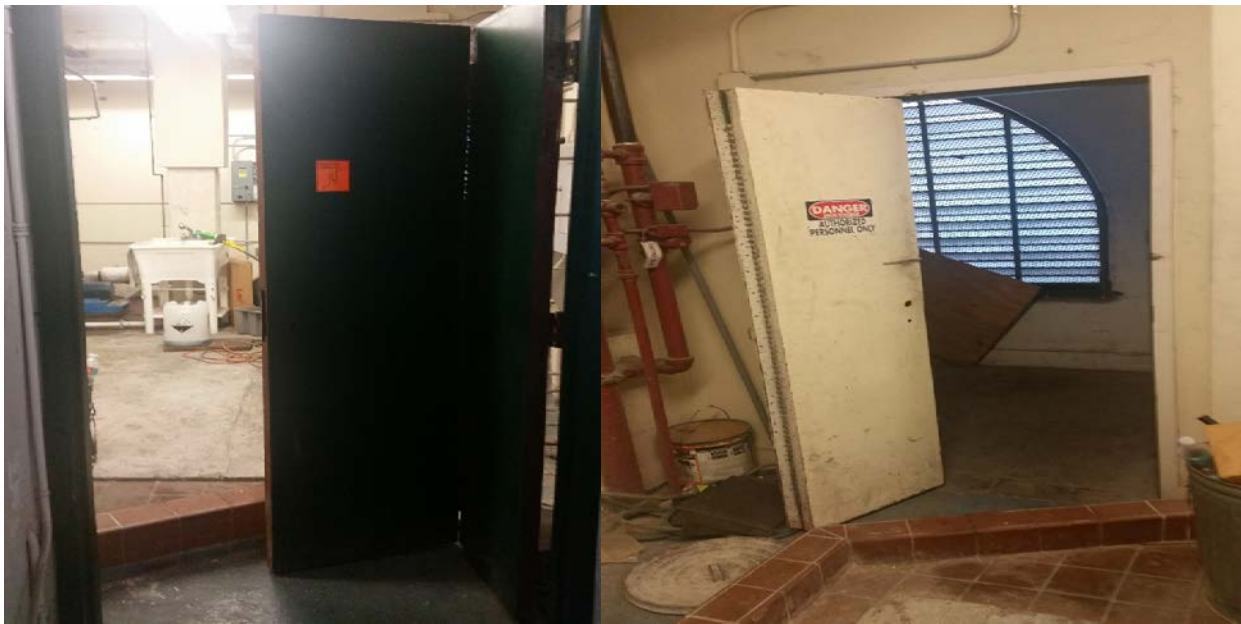
Existing bifold door at elevator equipment room (interior and exterior)

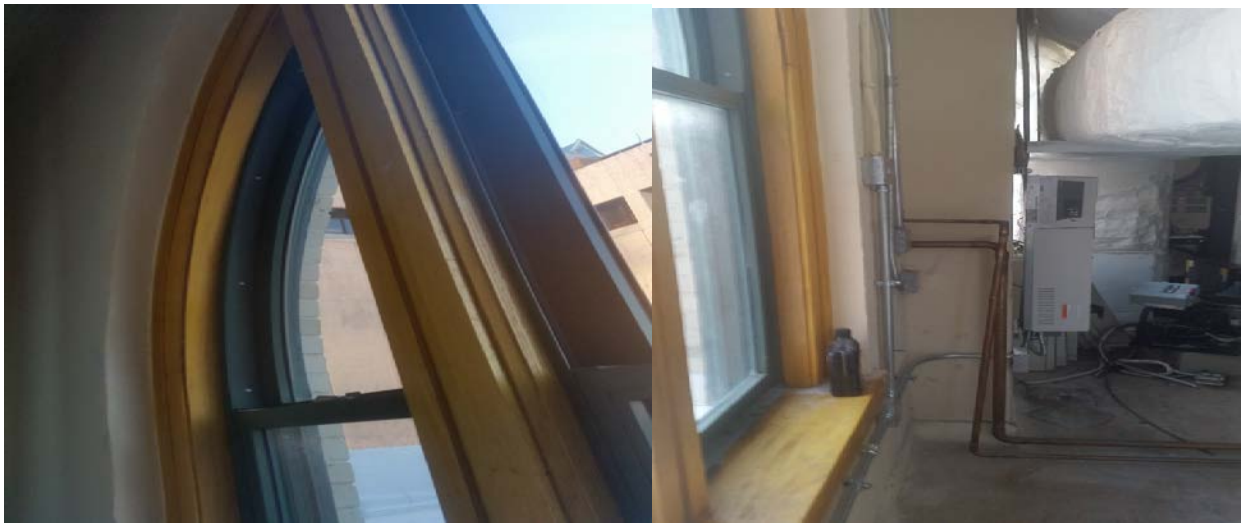
Examples of wood trim surrounding existing windows

The existing interior window trim and baseboards need to be removed in order to apply a thin peel and stick membrane between trim and the plaster finish around the windows to better seal them and bring the interior environment up to the same level of protection recently achieved with the exterior improvements. In general, all of the interior surfaces are to be examined and if necessary, selected demolished, cleaned, encapsulated and painted in order to improve the interior appearance.

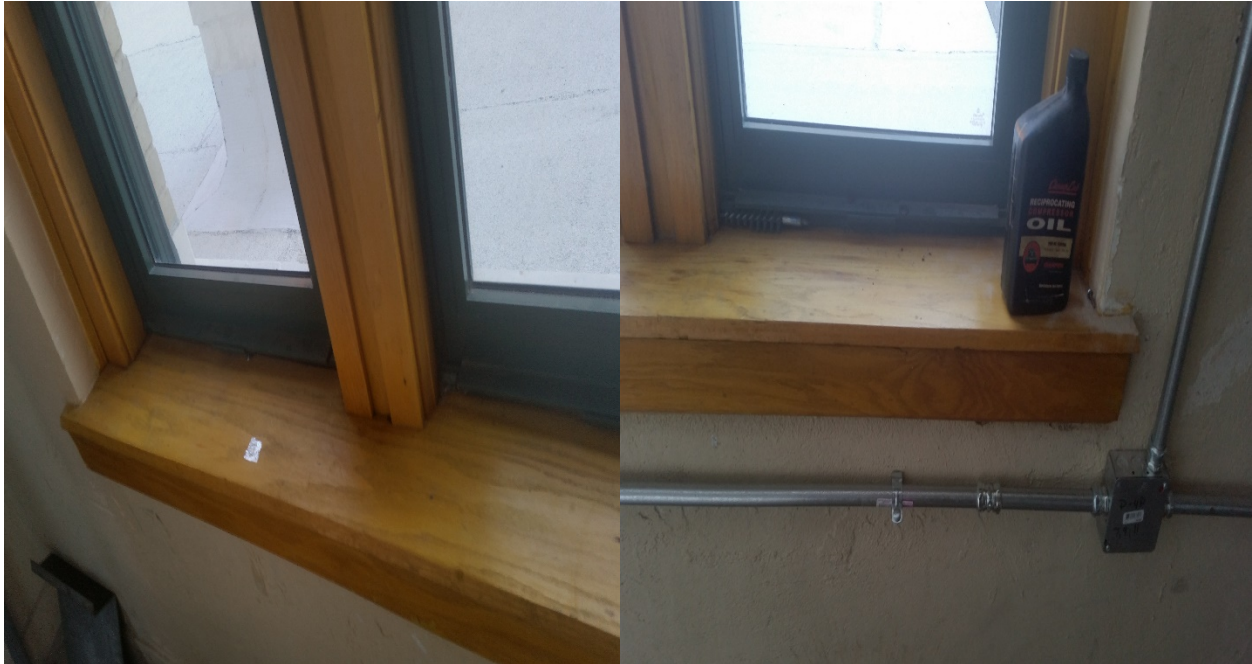
Additional details surrounding existing windows
