# El Prado Blvd.

MOBILITY OPPORTUNITIES AND  
DEFICIENCIES AUDIT  
2020

DECEMBER 2020

**CITY OF TAMPA**  
**MOBILITY DEPARTMENT**

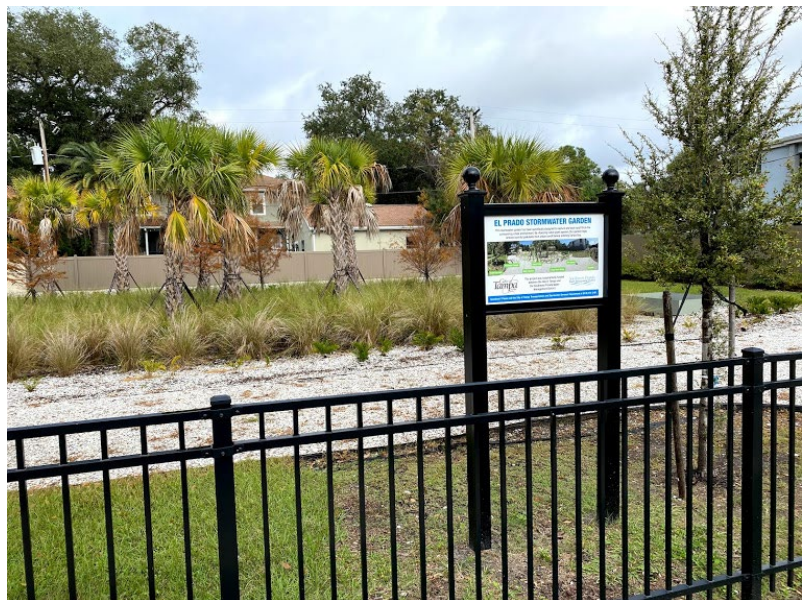
**Figure 11: Existing El Prado Stormwater Pond**

Landscaping can improve traffic calming and provide a sense of place making the corridor more accessible and inviting to pedestrians and cyclists. Also, amenities, such as bike racks near attractors, can lead to a more successful multimodal network. These components should be considered during design. The City should explore access to the El Prado Stormwater pond.
